Name Of Dam: UPPER NORTH RIVER, NO. 77 (HEARTHSTONE LAKE)

PHASE I INSPECTION REPORT

NATIONAL DAM SAFETY PROGRAM

MICHAEL BAKER, JR., INC.

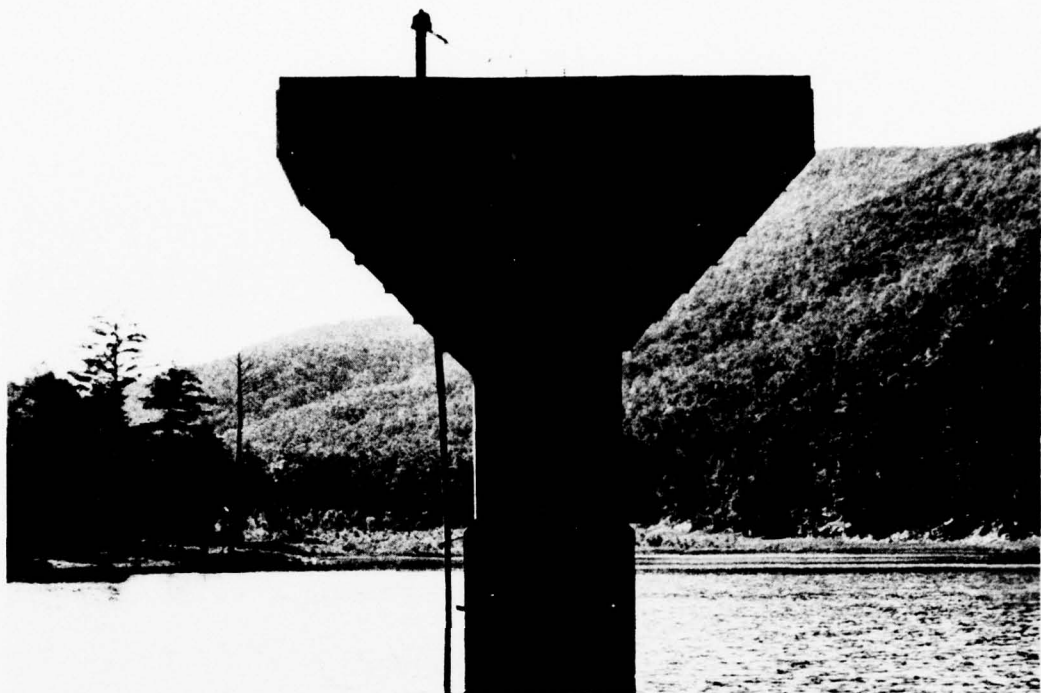
PHOTO 3

- No other seeping or sloughing was observed during the inspection. A few small trees were noted growing on the embankments.
- 3.1.3 Appurtenant Structures: At the time of inspection, some minor debris was lodged in the trash rack covering the normal pool inlet. The pipe encasing the lift stem for the pond drain is slightly bent (see Photo 3), possibly from the buildup of debris and/or ice. The lifting mechanism should be used to check for normal operation.

- 1) The small trees growing on the embankment should be removed.
- 2) Debris should be removed from the trash rack.
- 3) The stem and pipe casing should be repaired if the bent pipe hinders the operation of the slide gate.
